FM PROJECT ENVIRONMENTAL IMPACTS, MONITORING, AND MITIGATION

Derek Ingvalson FM Project Environmental Manager

ND Water Resources Research Institute Conference August 19, 2024

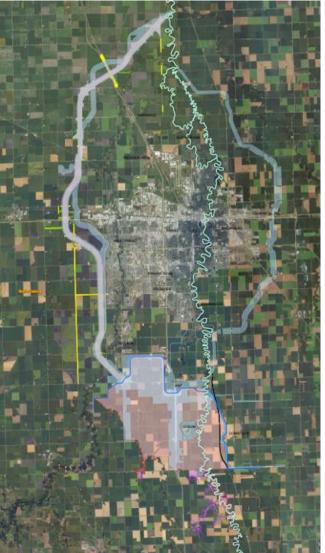
Cultural Resource Investigation Areas

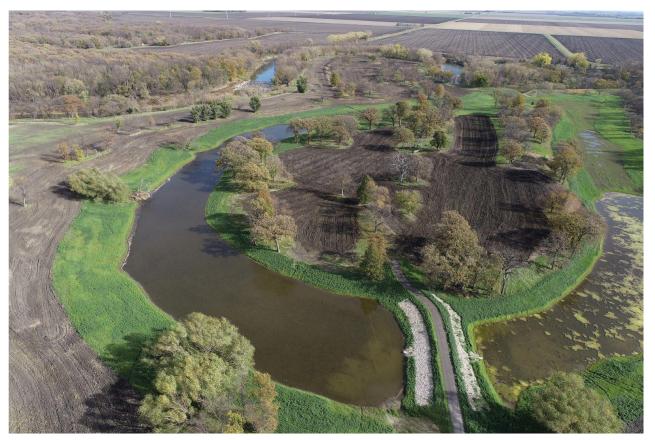
Oxbow Country Club Mitigation, Fall 2021

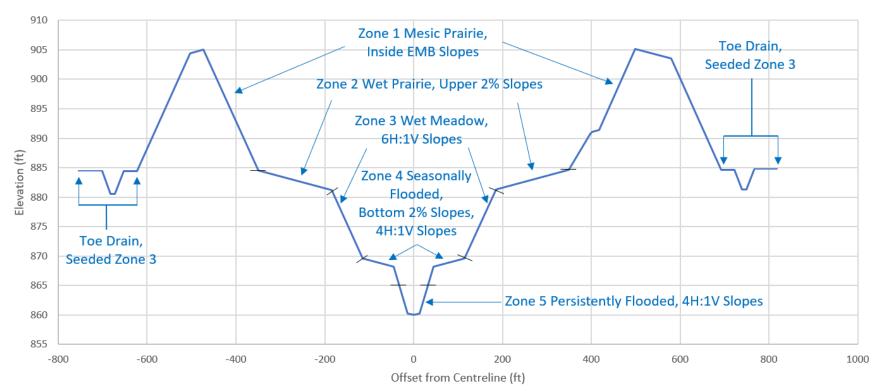
Channel Cross-Section - Channel Sta. 300+00

- Diversion Channel Mitigation
 - 1,095 ac required
 - Planted with native seed mixes

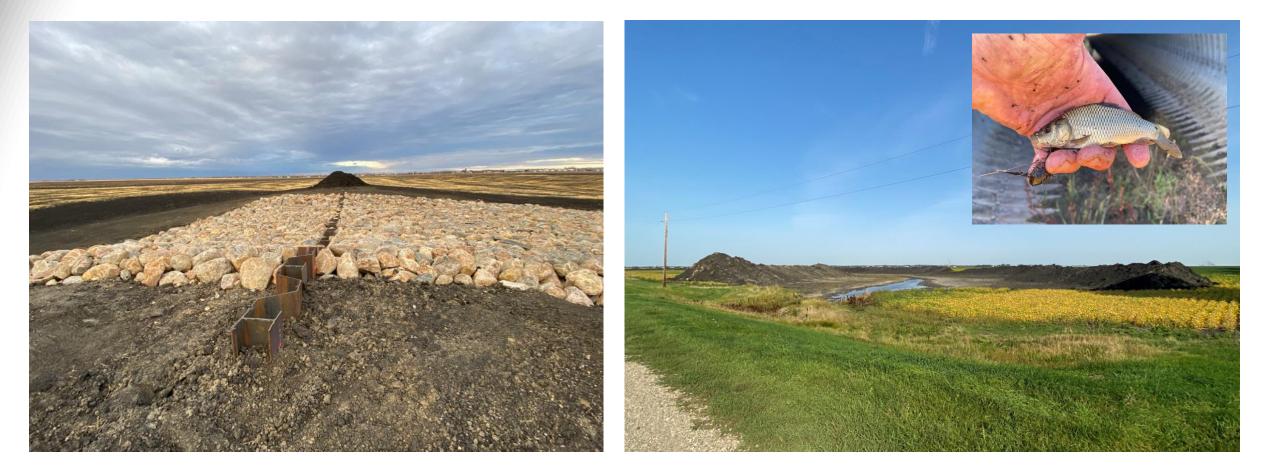
Drain 27 Wetland, Fall 2022

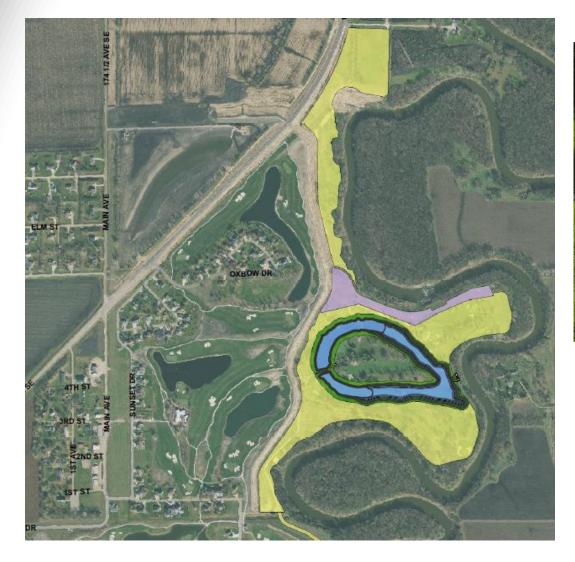
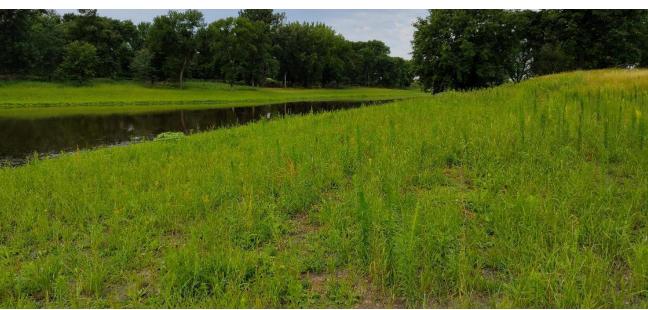
Oxbow Country Club Mitigation Site

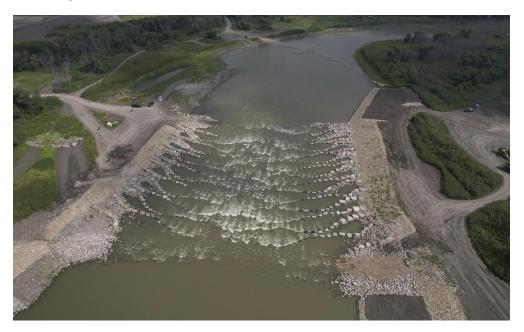
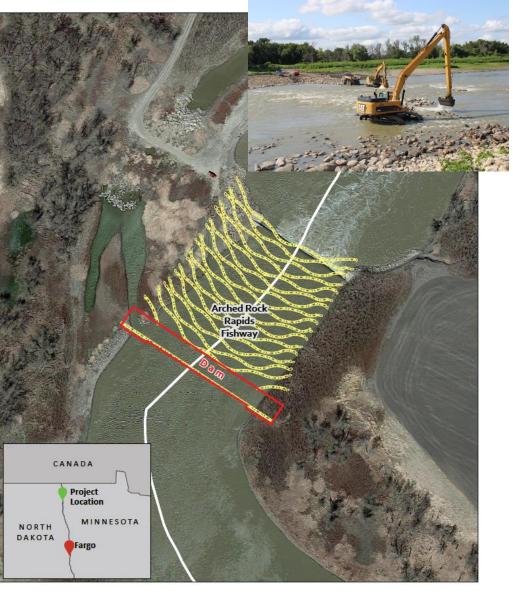
- Drayton Dam
 - Willow planting all that remains
 - Last major impediment to fish passage on the Red River
 - Replaced dam with arched rock rapids fishway

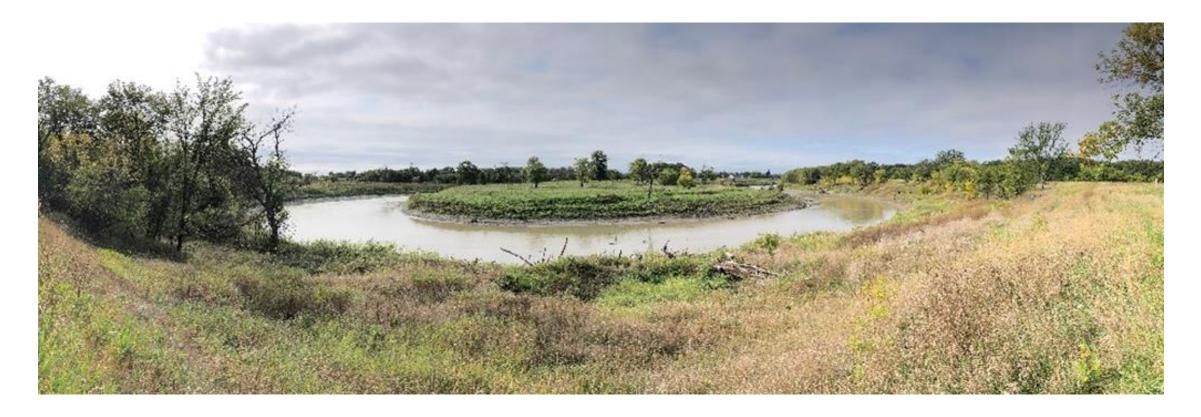
- Evaluating how the river shape and location changes over time.
- Field work completed in 2011, 2018, and 2020
- Analysis includes:
 - Cross-sections
 - Thalweg profile
 - Soil samples
 - Aerial photo interpretation
